Condition Assessment
&
Reserve Fund Plan
2017
Lake Vista

Forest, Virginia

RE: **CONDITION ASSESSMENT AND RESERVE FUND PLAN 2017**
Lake Vista Property Owners Association
Forest, Virginia
Project No. 8293

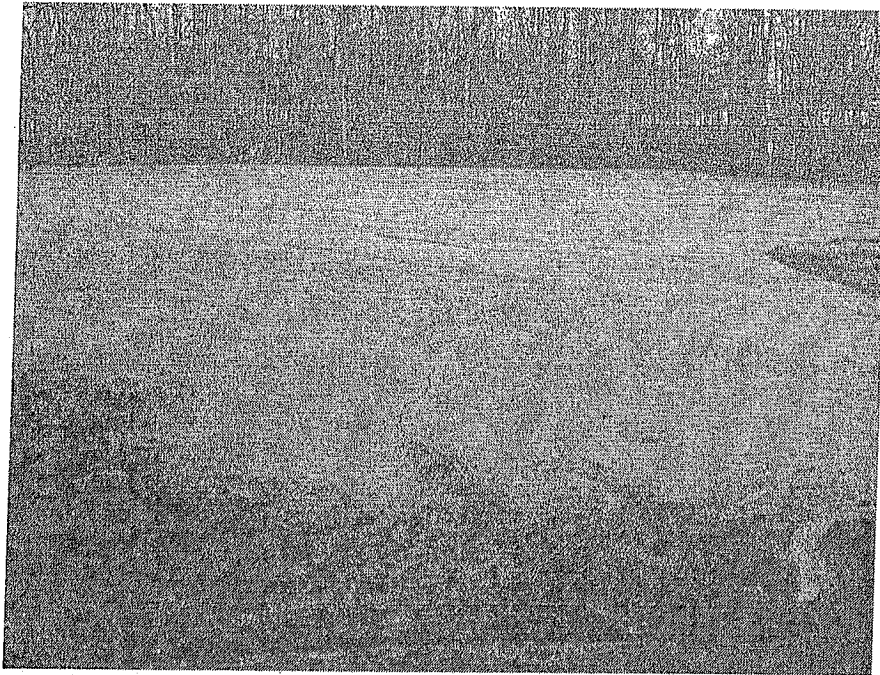
PHOTO #1
The asphalt driveways and parking bays at the community center and Hutter Lake Trail range from fair to good condition. Seal coating and crack filling was completed circa 2012.

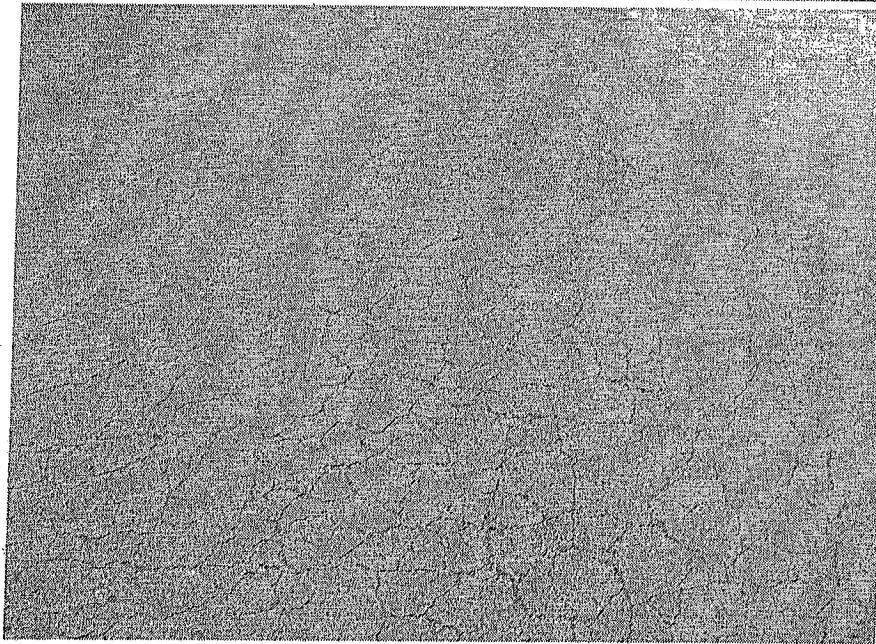
PHOTO #2
One area of severely deflected pavement at the upper parking area requires full-depth repair near-term.

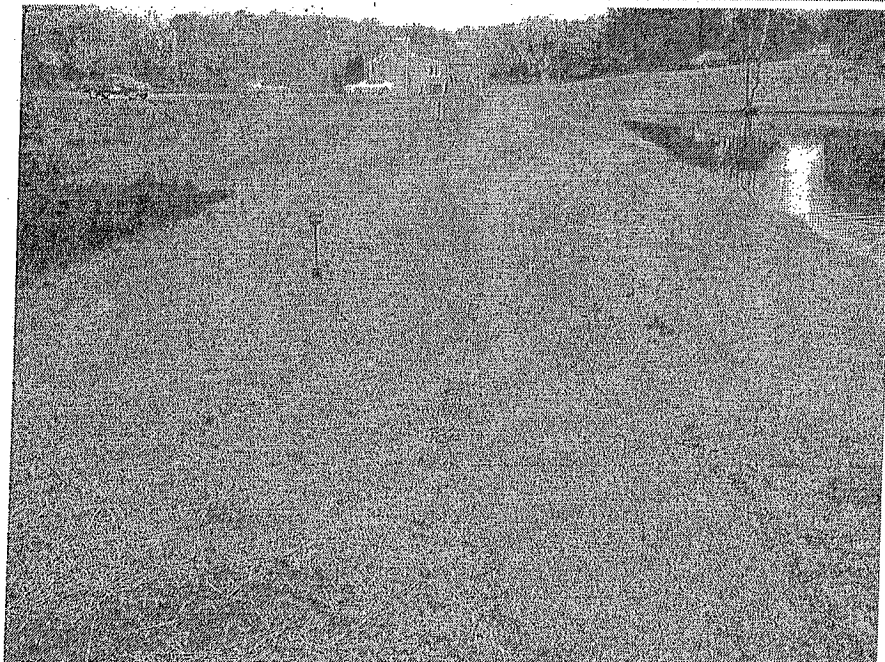
PHOTO #3
The asphalt footpaths range from new to fair condition. Any tripping hazards on the trails should be mitigated. Path lighting is new, but six of the lights were out of service.

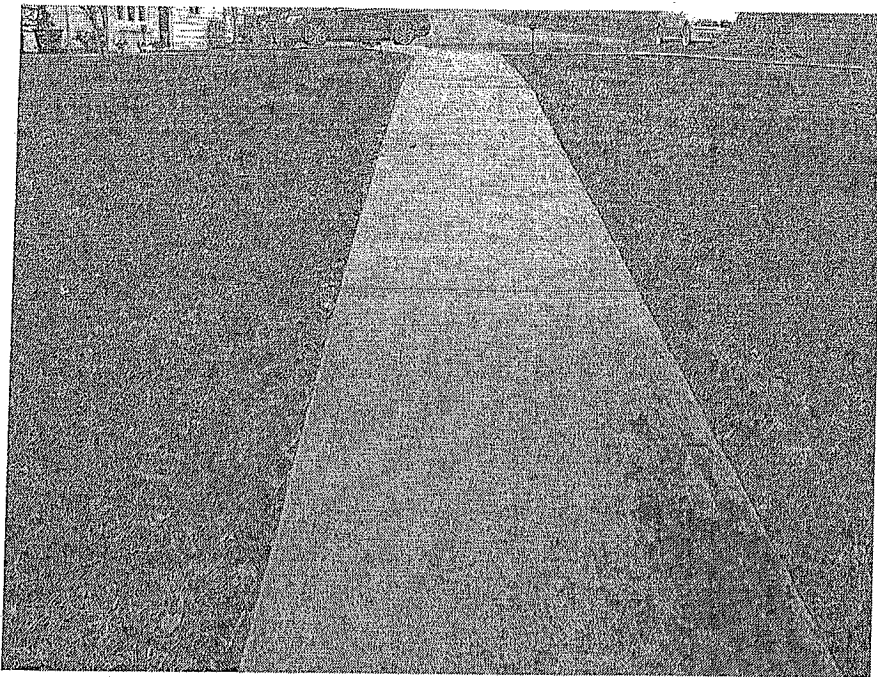
PHOTO #4
The concrete sidewalks and the pool deck are in excellent condition, with no major deficiencies noted.

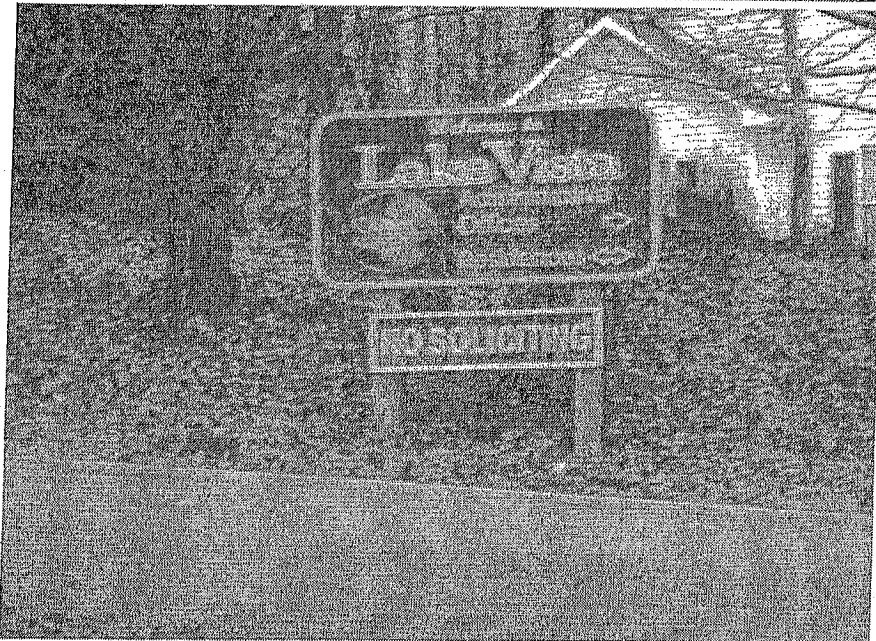
PHOTO #5
The carved wood signs throughout the community are in good condition. Maintenance of the signs, such as annual painting should continue.

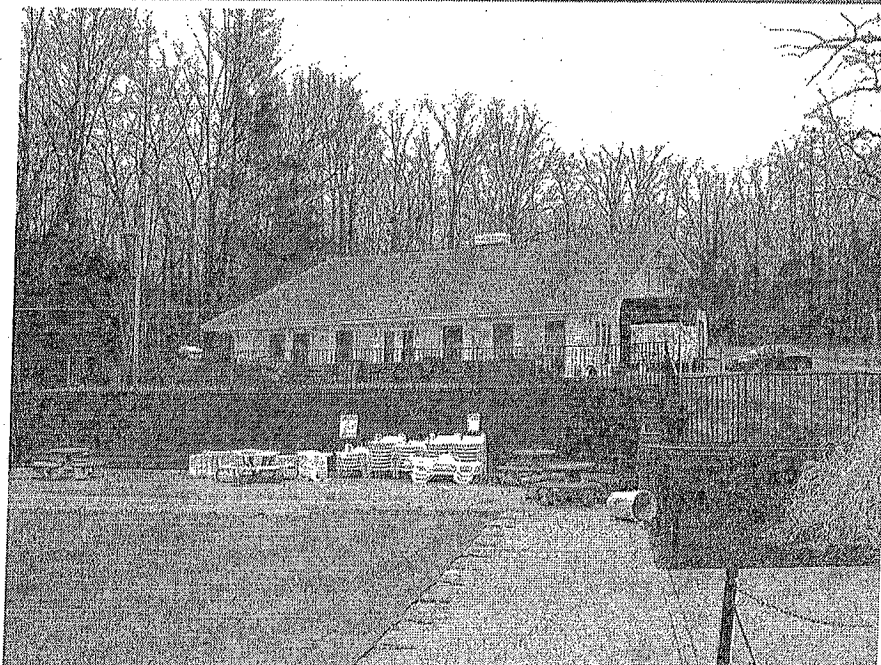
PHOTO #6
The modular block retaining walls at the pool and behind the community center are in good condition.

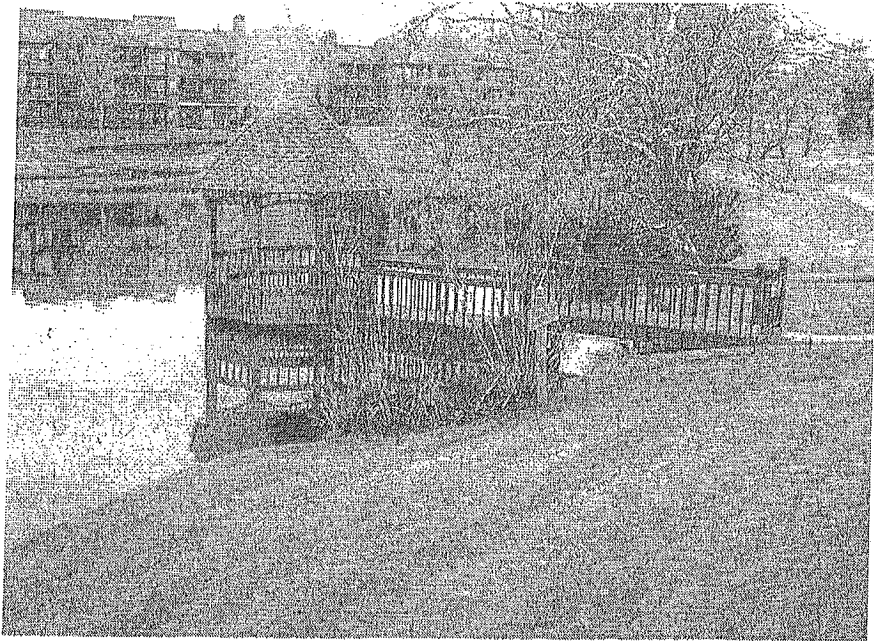
PHOTO #7
The wood gazebo, roofing, and the footbridge leading to the gazebo at Hutter Lake range from fair to good condition.

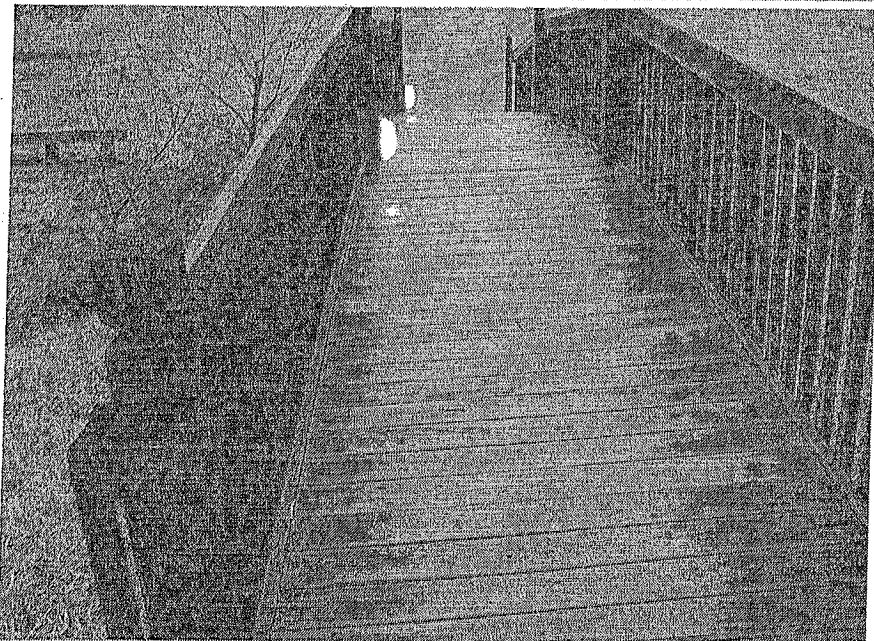
PHOTO #8
The wood footbridges at the footpaths also range from fair to good condition. This bridge is deflecting to the left side. We have scheduled bridge replacement in the next couple of years.

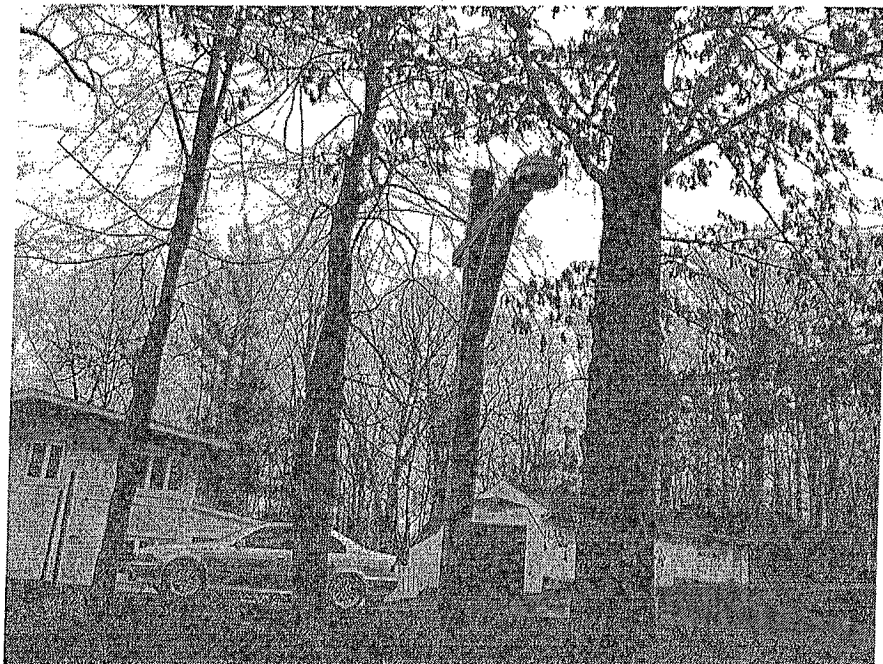
PHOTO #9
The wood light poles and fixtures were recently restored and appear to be in good condition.

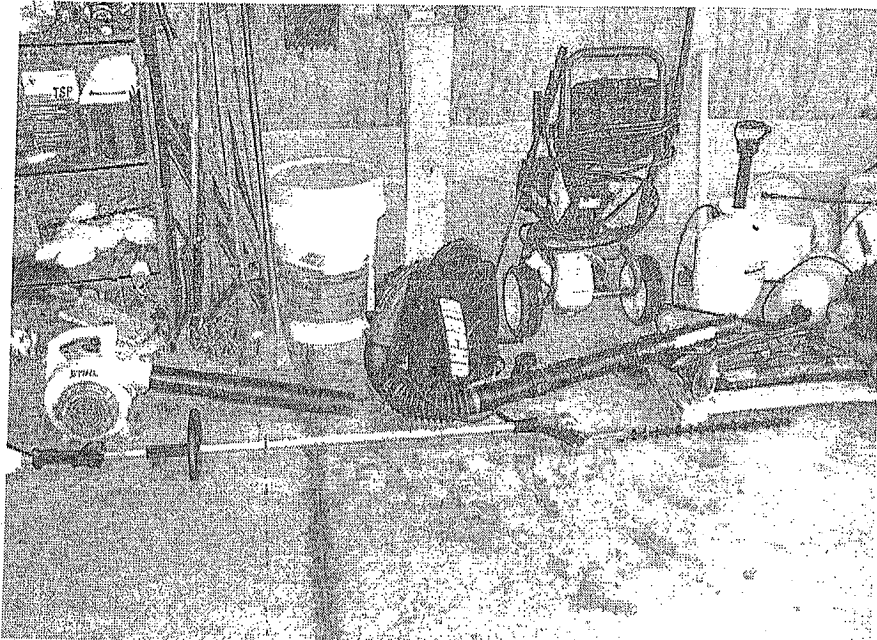
PHOTO #10

This is an example of some equipment used in maintaining the community, and located in the shop. We have provided an allowance for partial equipment replacement over the 20-year period.

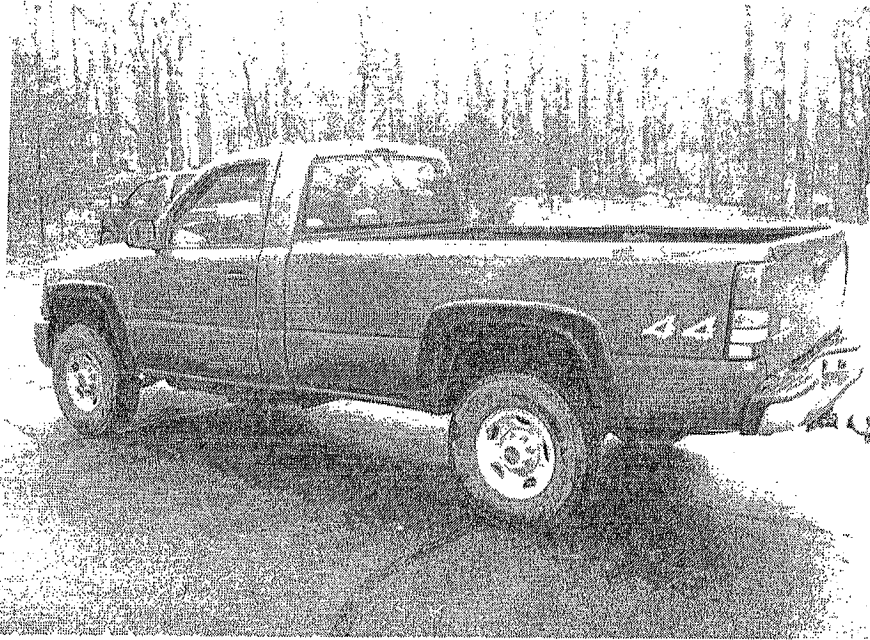
PHOTO #11

One of two work vehicles, showing signs of wear and tear. This truck is scheduled for replacement in a few years. The bobcat is new and is in good condition.

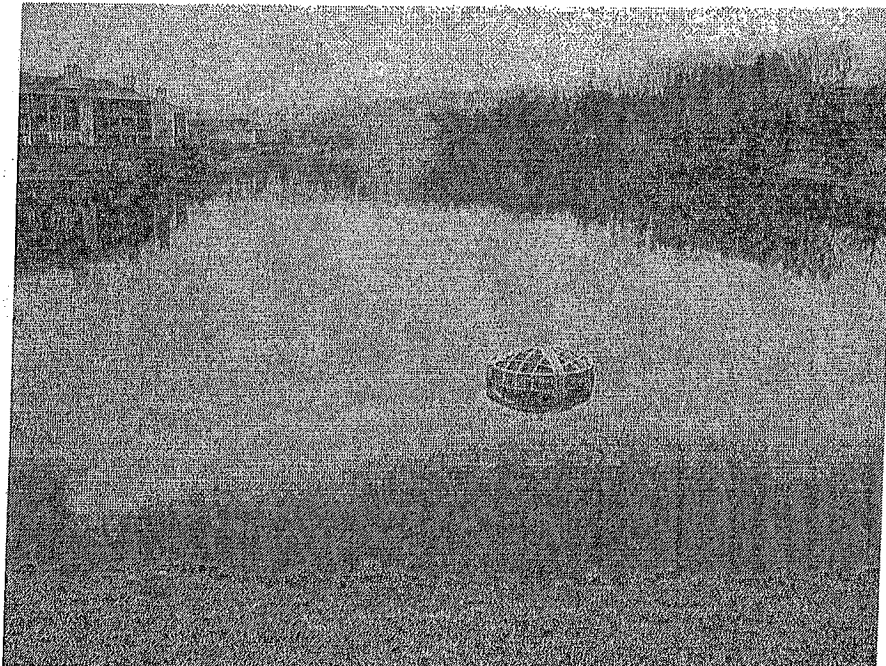
PHOTO #12

An overview of Lake Vista. The lake was formed as a result of excavation and construction of earthen impoundment structures. Water exits the lake through this overflow riser, which drains below the impoundment structure.

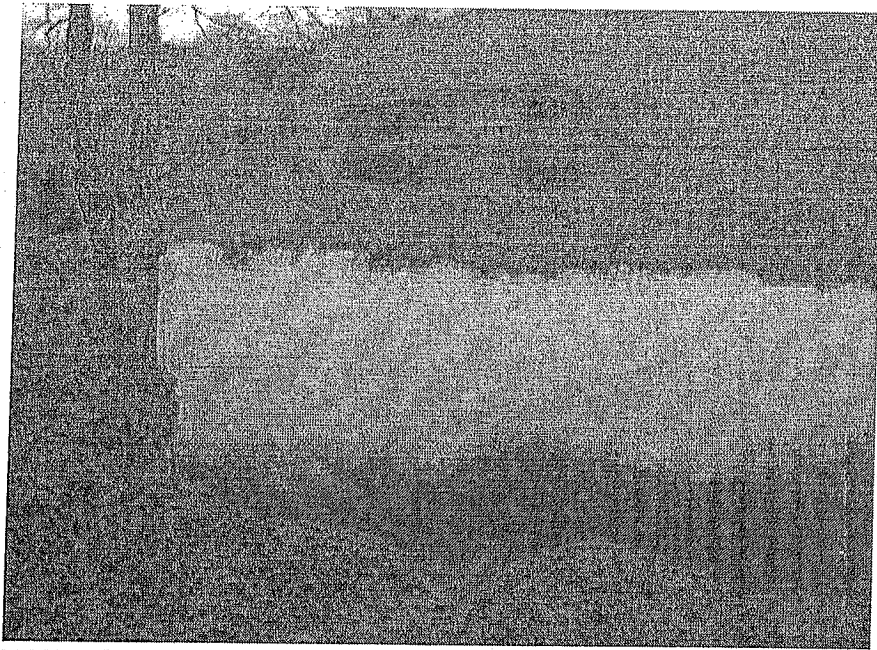
PHOTO #13
An overview of Hutter Lake, which appears to be in good condition. No major vegetation was observed at this retention pond.

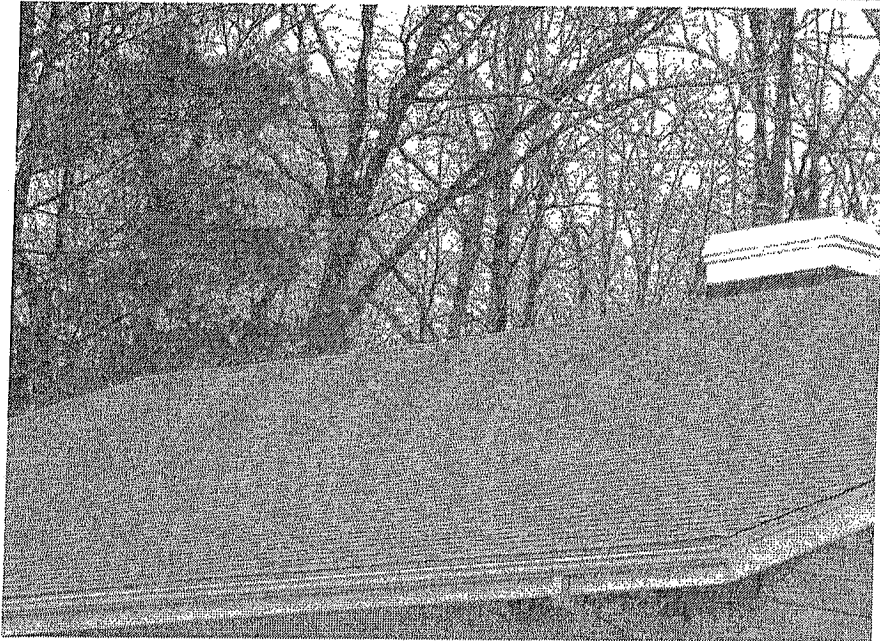
PHOTO #14
The asphalt shingles of the community center, pool pump house, pool bathhouse, and the garage/shop appear to be in good condition, having been restored circa 2014.

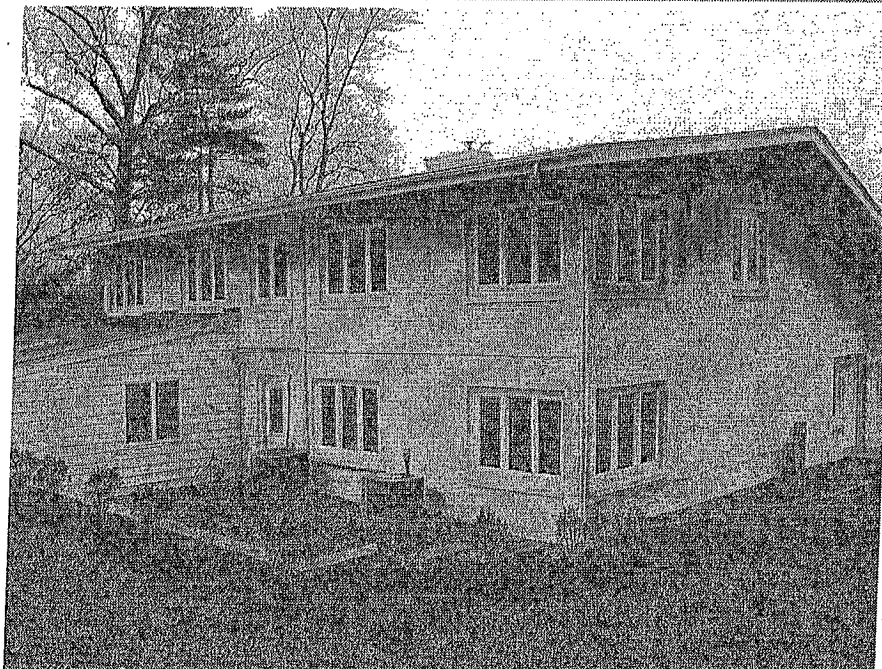
PHOTO #15
The brick and mortar veneer of the community center, wood trim, and the siding on the garage/shop are in good condition.

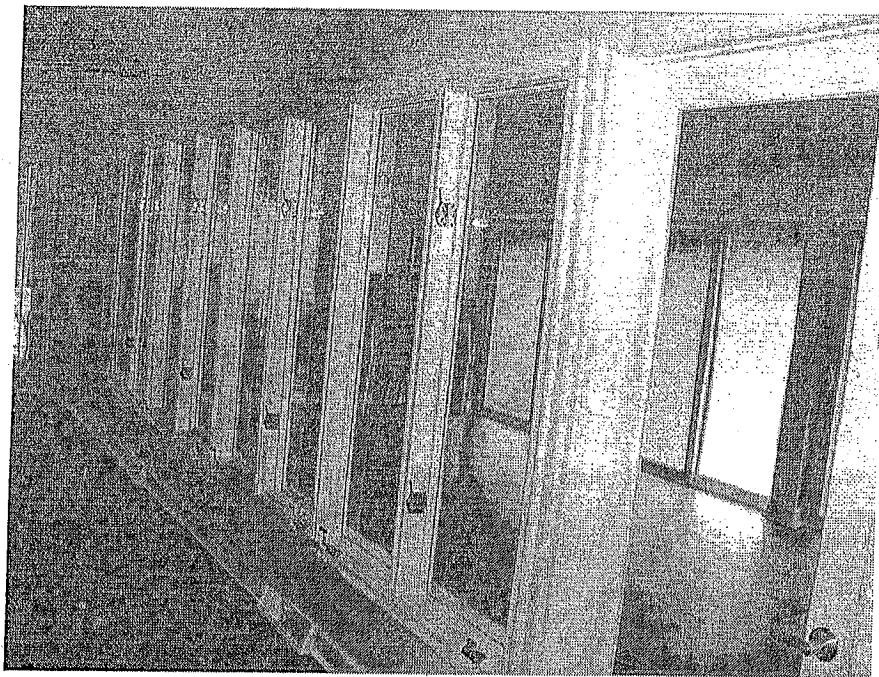
PHOTO #16
The windows and doors of the community center were recently replaced and are in good condition.

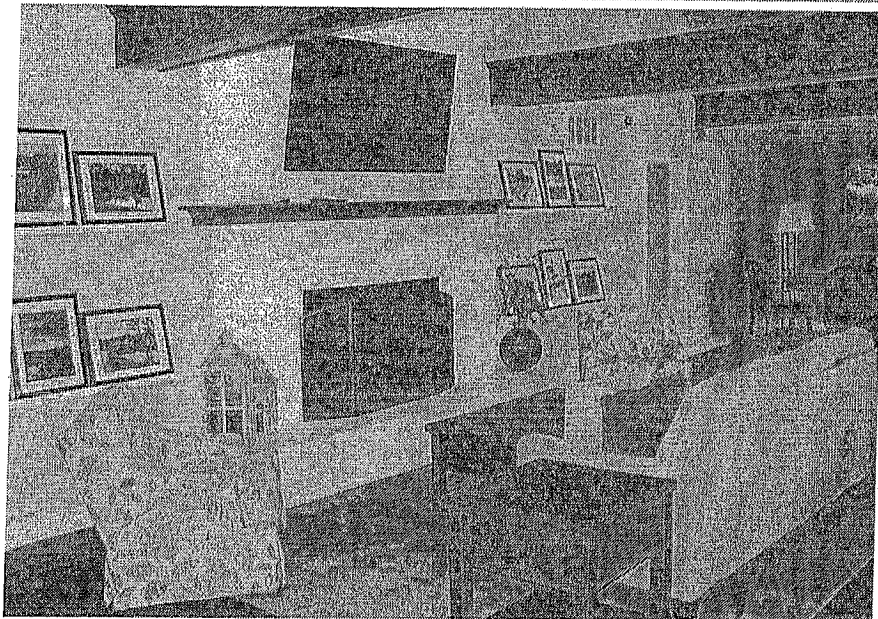
PHOTO #17
The community center was recently refurbished, including new tile, refurbished wood floors, new paint, new lighting, and new bathroom fixtures. The interior furnishings are in like new condition.

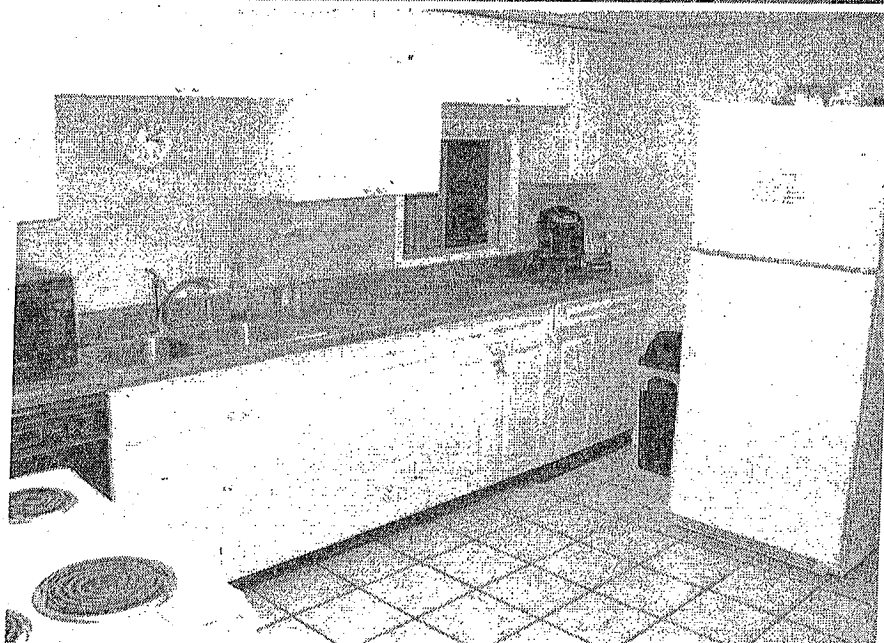
PHOTO #18
The kitchen was last refurbished circa 2002 and it appears to range from fair to good condition.

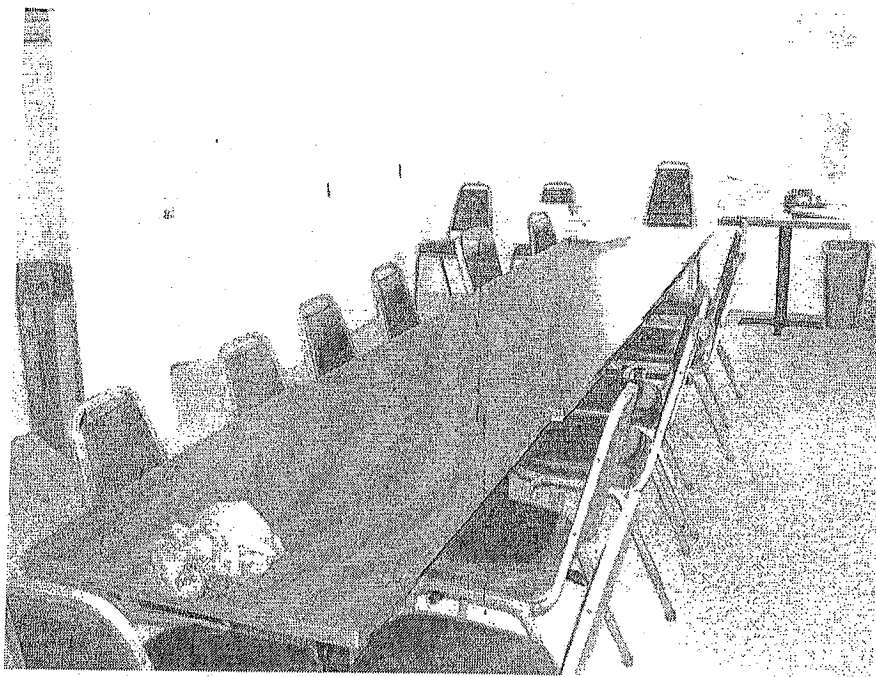
PHOTO #19
Furniture and equipment in the office and the conference room are dated, and range from poor to fair condition.

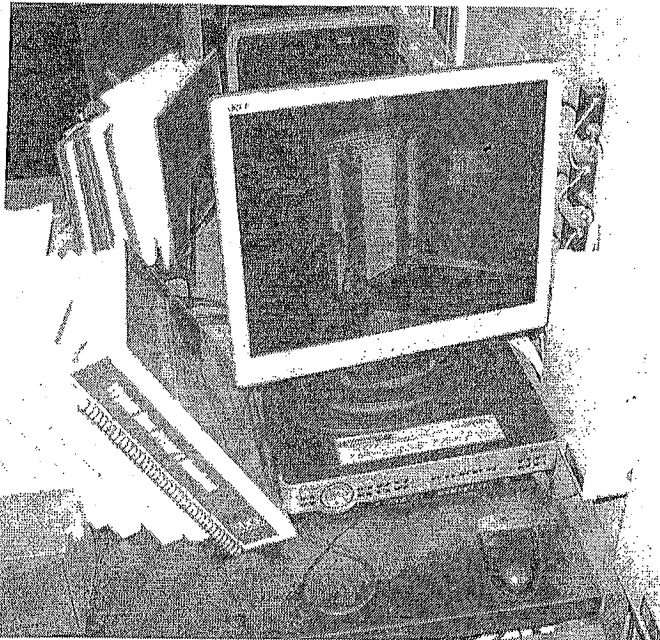
PHOTO #20
The security camera system was operational at the time of our site visit, with no reported issues.

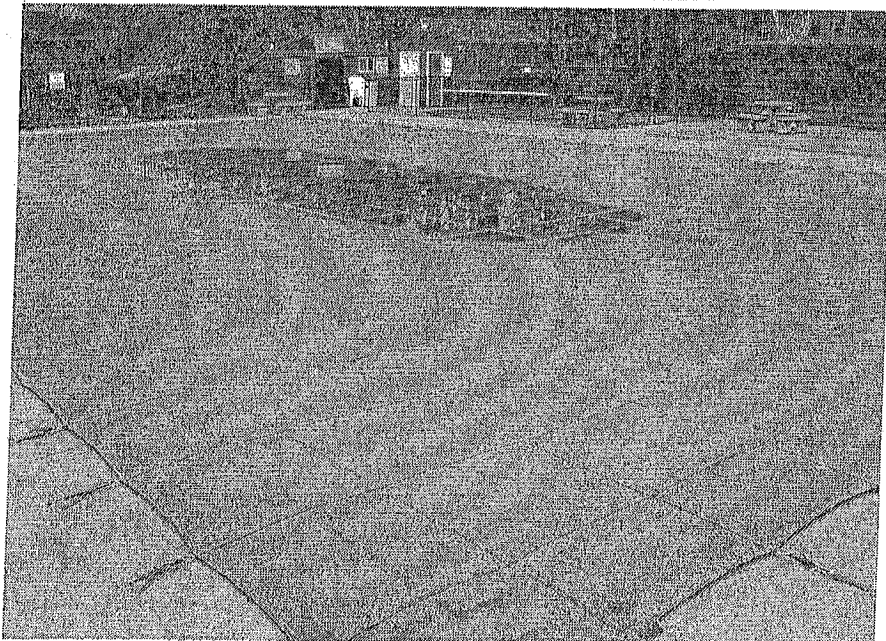
PHOTO #21
We understand that the pool was enlarged to an Olympic sized pool circa 2001-2002. No problems were reported with either pool.

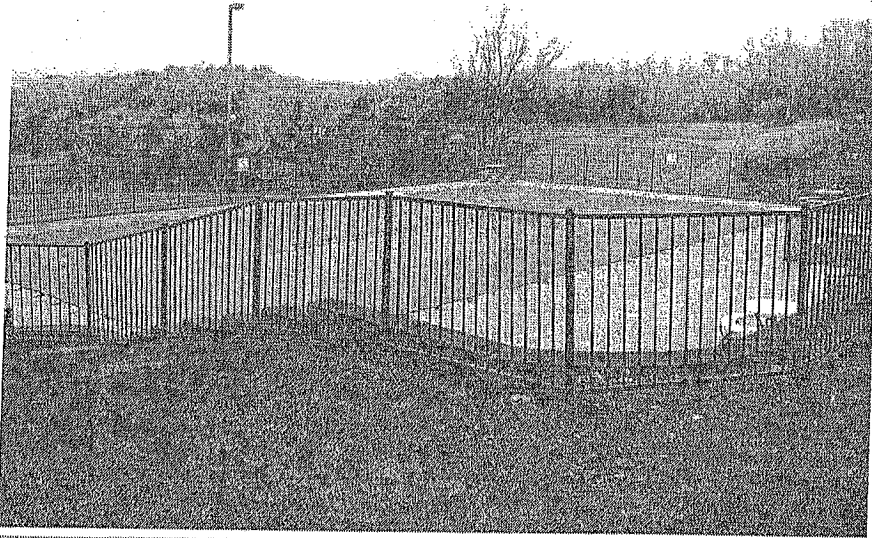
PHOTO #22

The metal fencing at the pools range from fair to good condition. Fencing will require painting to improve appearance and maximize service life.

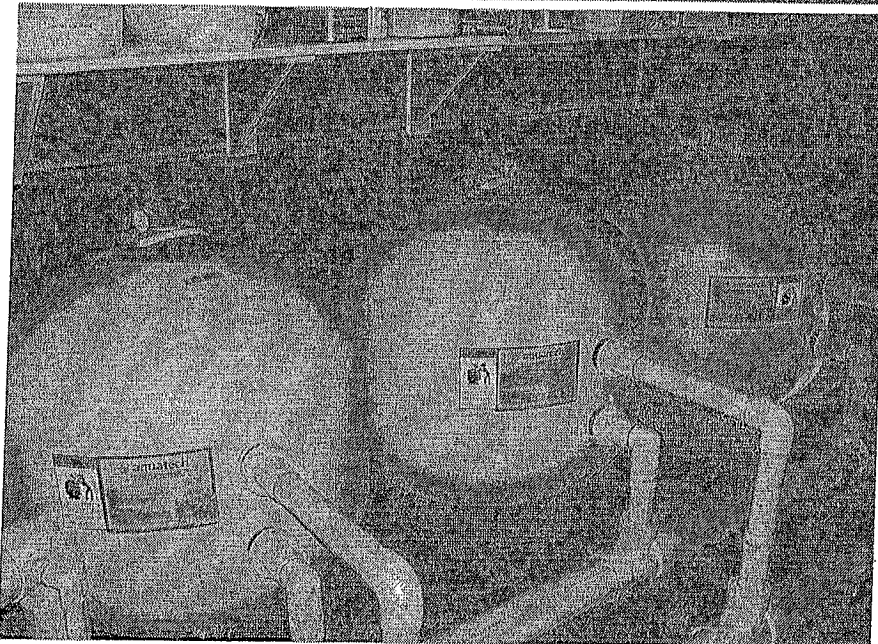
PHOTO #23

We understand that the pool filters and pumps were replaced circa 2013. The equipment was decommissioned for the season, but appears to be in good condition.

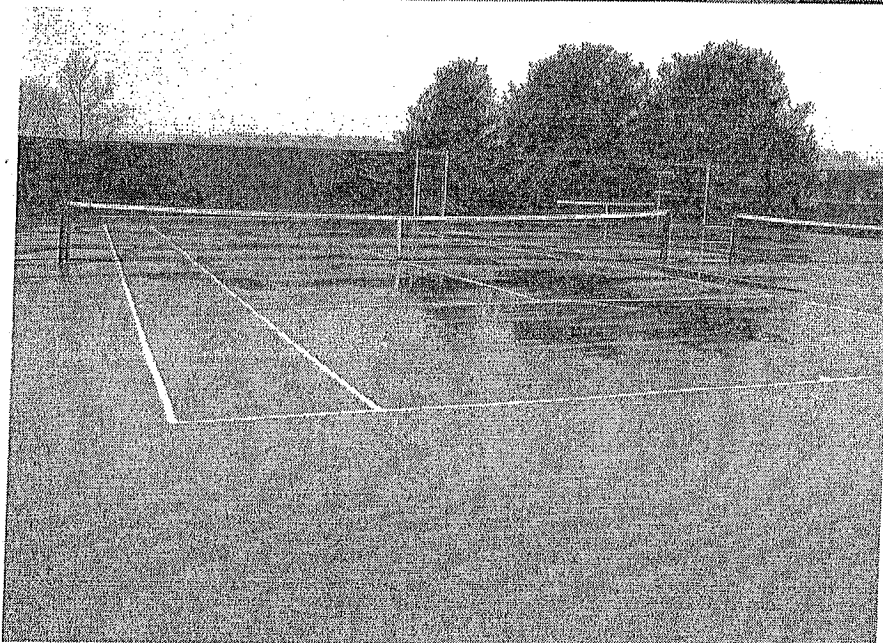
PHOTO #24

The tennis courts and fencing were restored circa 2016, and are in very good condition.
